IMR WR Alliance - Whitlingham

Claret Lining Division

Anglian Water IMR WR Alliance

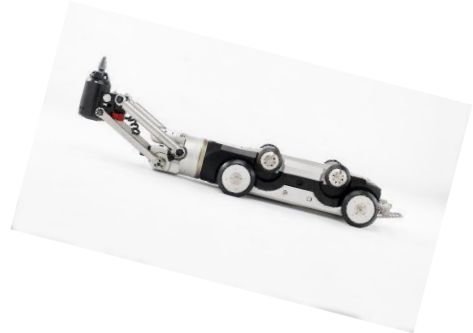
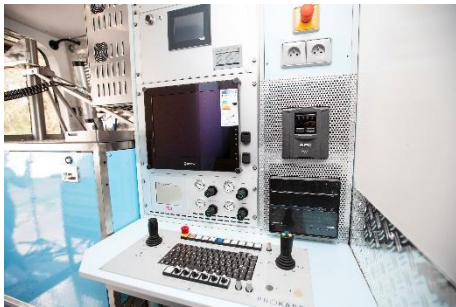
The resolution was to find materials that could offer structural support of the existing host pipe and to mitigate the infiltration coming into the sewer through different inlets. The varying diameter throughout the sewer had to be a consideration because of the corrosion. The sewer's actual installed concrete pipe diameter was originally 250mm but was reading 270mm/280mm in places where we could measure the pipe work. The 174m length of sewer was shallow and in ground that would make the installation difficult due to its location to deploy equipment.

The solution for the failing asset would be to clean the sewer with high pressure water recycling jetter to remove any debris from the sewer before sending in Claret's new state of the art electric powered Prokasro Robotic

Cutter to remove the multiple tree roots that were protruding into the sewer. This was achieved successfully and allowing the lining managers to have a closer inspection to the condition of the asset. It was concluded that we utilise a transition lining that would stretch from the 250mm diameter into the area that had been corroded and utilising a WRc approved Epoxy Resin that is great for sewers that are infiltrating but can also be cured with LED light.
