*Claret Lining Division*

*Anglian Water IMR WR Alliance*

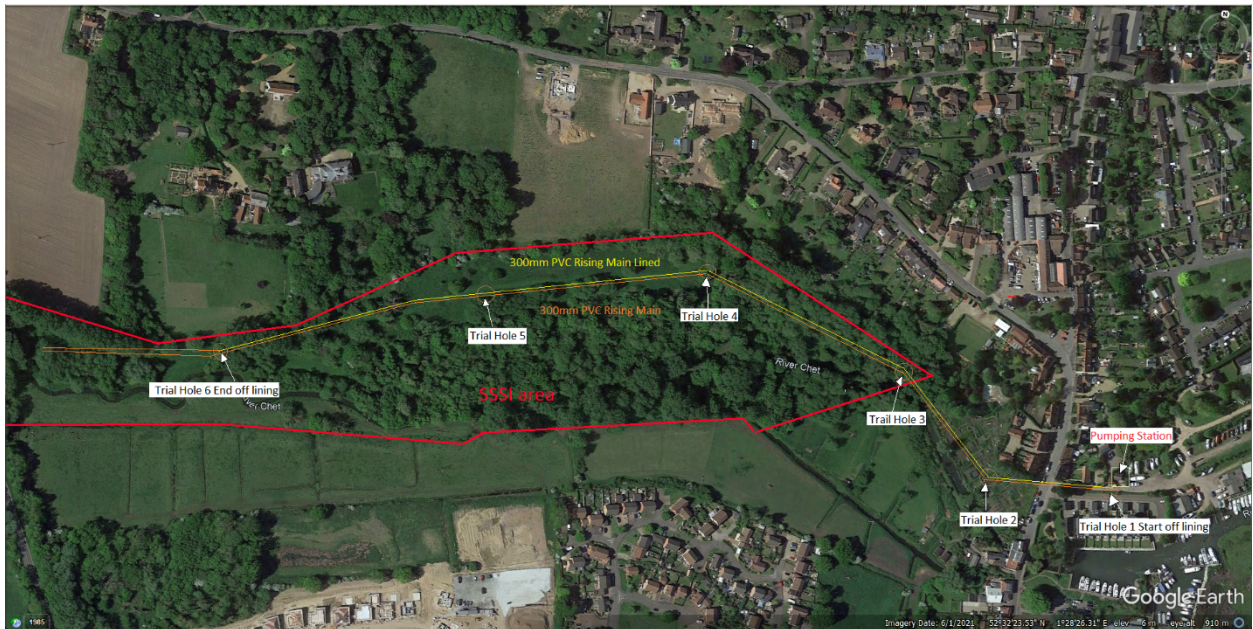
*It was reported that ground was unusually wet in a conservation area near to Loddon & Chedgrave by some ramblers & dog walkers. Anglian Water deployed a team to investigate and found that their pumped main had been leaking into the ground in several places. Fortunately, flows were switched over to another pressure main which was lay next to the defective pipe to allow further investigation. Known hatch boxes were opened to allow for a full CCTV survey of the failing asset.*

*The conclusion from 713m x 300mm rising main survey was that a lot of joints had failed due to poorly installed pipework and had deteriorated over time. A permanent solution was required that was supportive of the existing pipe, able to withstand internal pressure of up to eight bar but also external pressure resulting from hydrostatic, soil and live load situations. The other complication to the site, was that it was part of the 123-acre Hardley Flood biological Site of Special Scientific Interest in Norfolk. It is part of the Broadland*

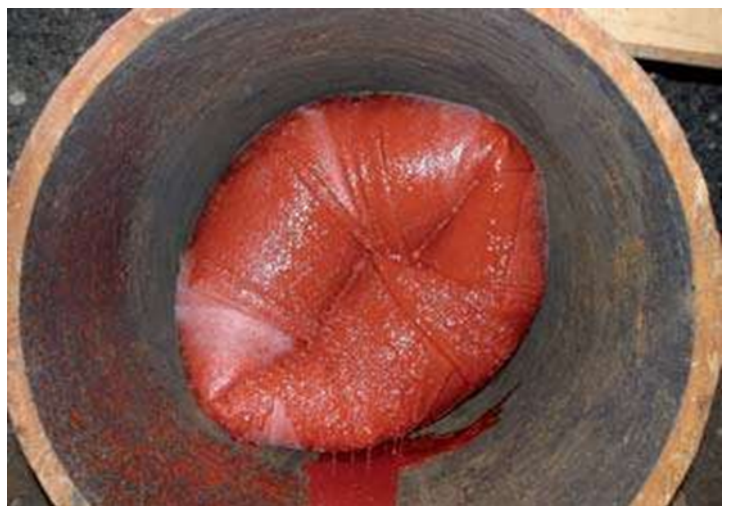
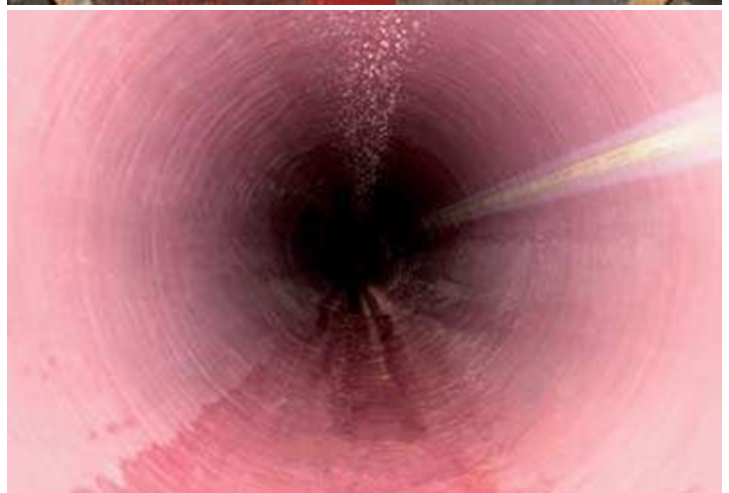
*The NORDIPIPE™ liner for Loddon consisted of a combination of a coated felt, two glass-fibre layers and an additional layer of felt. The glass-fibre layers in the liner have excellent characteristics when in tension and therefore this makes the NORDIPIPE™ an extraordinarily strong, but flexible liner. It has its own intrinsic strength and stiffness and therefore does not rely on the host pipe for structural support, though it needs to be in close contact with the host*

*pipe to maximise the final lined pipe's cross-section, and to enable the ends to be sealed off properly.*

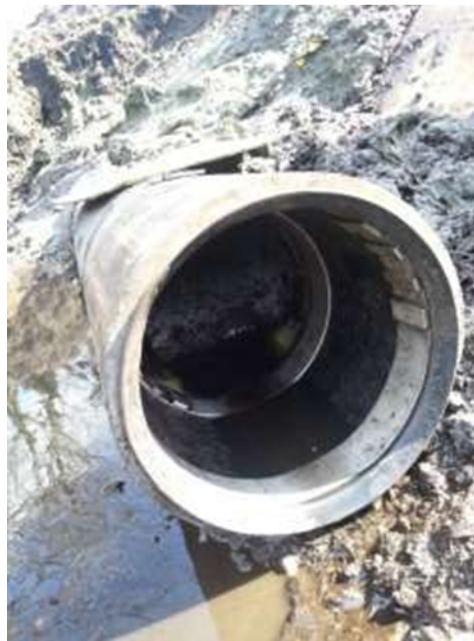
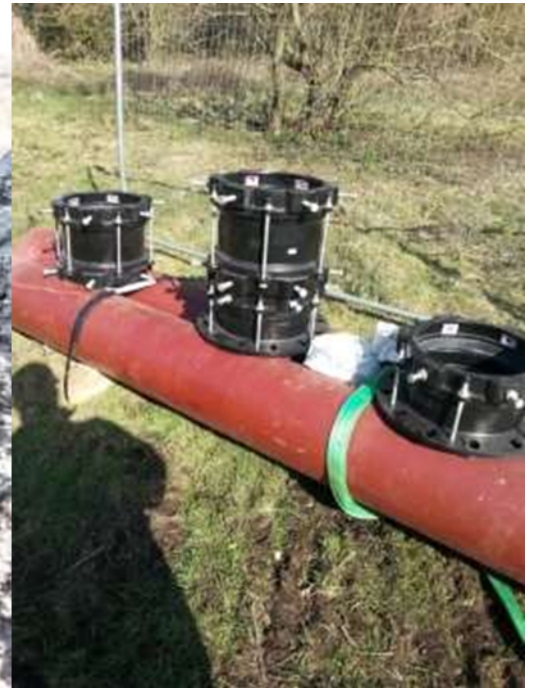
*Also, for this project, Weko end seals were fitted to prevent water from migrating along any annular gap that existed between the NORDIPIPE™ liner and the host pipe. This was particularly important as a hydrostatic pressure test was performed upon the installed liner once the pipeline was coupled back up to the remainder of the pipeline.*

*Testing was successful and the pipeline was put back into service a few weeks later.*
