## Which Claret Civil Engineering business are you?

*Claret Lining Division*

*Groupbridge Ltd working for the National Trust.*

*Paycockes Cottage in Coggeshall is a Tudor Merchant Property that was built in 1509 by Thomas Paycocke.*

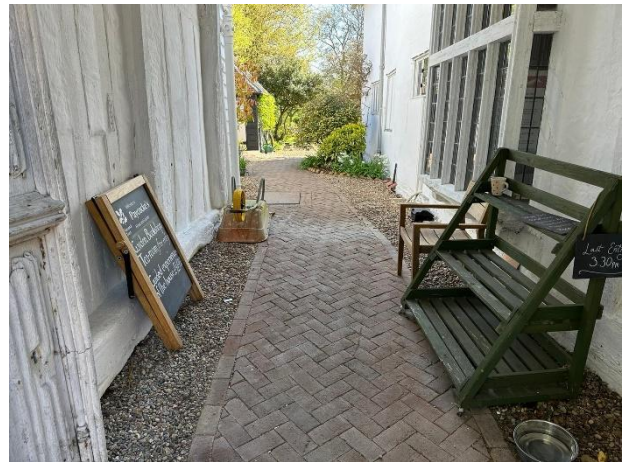
*Groupbridge, working on behalf of the National Trust, carried out an extensive survey of the sewer network to identify the current service condition. The conclusions were that there was considerable displaced joints and root intrusions to causes concern for future blockages.*

*The solution would be to provide structural segmental repairs (patches), to cover the displaced joints to have a smoother transition for residual flows with free-flowing solids. and that the root intrusions would be removed with specialist milling equipment followed by a structural patch to prevent further root intrusions from happening again.*
