*IMR WR Alliance - Whitlingham*

**Claret Lining Division**

*Anglian Water IMR WR Alliance*

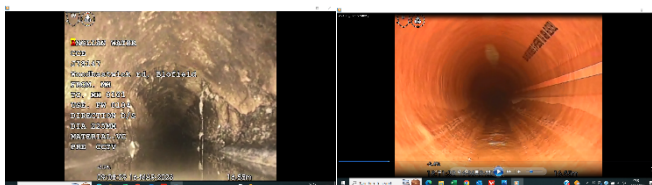
*The surveyed length of sewer that was failing 138m x 225mm concrete pipe that had been corroded heavily and all joints were failing and even showing large holes and splits, joint seals were protruding into the sewer and heav cracking throught the 138m run.*

*Straight away, the lining management after reviewing the CCTV data, realised that a method to be used, would have to maintain a constant pressure of the*

*new lining during the installation process. The lining division had a temporary scaffold design drafted and approved to build a launching platform from a tower to for the lining to create a constant head of pressure during the lining installation. A method long used and tested for over 50 years and ideal in these circumstances. The materials used would be a polyurathane coated felt liner designed at 6mm thick, impreganted with a Water Researc Centre approved Epoxy Resin.*

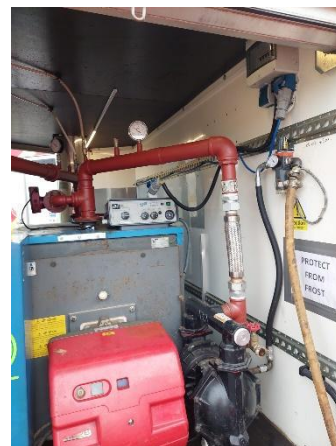
*A five-way traffic light set-up was installed to accommodate the plant, equipment & materials, the sewer network residual flows was taken out of service with a temporary overland bypass for the duration of the works giving the lining installation team a dry sewer. The scaffold was then built, the liner installed with final effluent (recycled water), the cold water was then heated and boiled through a lorry mounted boiler for a 6-hour period then suitably cooled down with cold water.*

*The newly made pipe was released of the water, the liner ends removed and the sewer network was restored giving the network a new jointless asset that would increase flow velocity by up to 30%, less impact on the environment and making huge carbon savings.*
