IMR WR Alliance - Whitlingham

Claret Lining Division

Anglian Water IMR WR Alliance

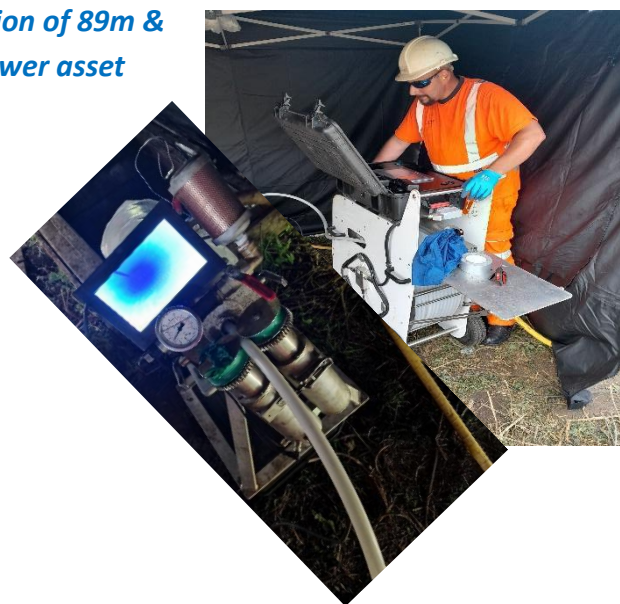
The Sewertronics LED system is small, compact, and versatile which lent itself to the location of the site. The successful installation of 89m & 85m was completed in two days and the sewer asset was put back into operation.
