Claret Lining Division

Anglian Water IMR WR Alliance

Anglian Water had received a complaint from All Saints House, Stokeferry, Norfolk, that sewerage was finding its way into their grade II listed building when there was heavy rainfall. An Anglian Water survey team was deployed to the site to investigate further.

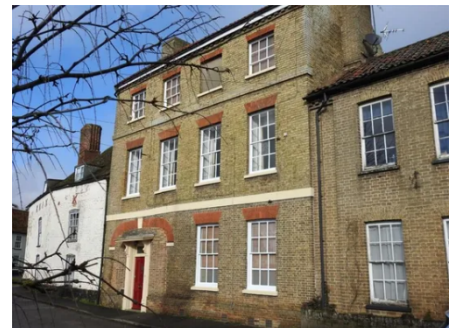
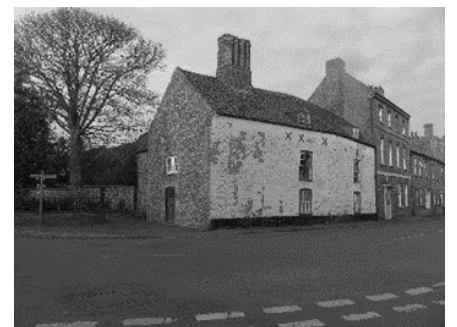
Further investigation with CCTV of the exiting asset, showed this sewer system to be of a brick construction with a slate bottom. The survey identified that the sewer was constructed prior to the building being built which was in 1752.

It also identified that the slate bottom had been built on bricks and some of the slate was missing in places leaving what looked like small troughs which made the surveys more difficult to capture and to identify the sewers actual diameter. The barrel shaped brickwork that surrounded the slate bottom was missing mortar and showing large gaps which explained how the seepage was getting into the cellar of the property of All Saints House. The survey was conclusive, and a suitable solution had to be found to rehabilitate this 271-year-old asset with a trenchless technique that would not compromise the movement of the existing brick work and to ensure that it had a fully deteriorated design that would stand alone without the need of the existing structure.

The installation of 15m x 300mm x 4mm GRP Bluelight Lining was carried out and cured in just a few hours and then a cementitious material was injected into the annulus (gap) between the new lining and the host pipe to support both old structure and newly lined pipe. A post survey was carried out of the new lining which concluded that the rehabilitation was a success and was testament to great collaboration between these
