Interceptor Removal

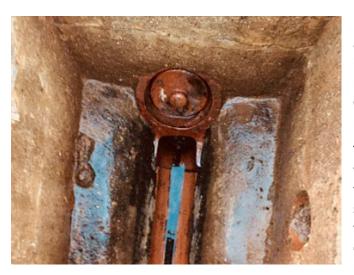
Drainage interceptors/Buchan/Winsor traps were originally installed to prevent sewer air from venting within domestic systems at a time when the authorities were unsure of the health risks and dangers that this foul air may carry, even at the time there were those who opposed the installation of the traps because they cause waste matter to sit in the outlet of a chamber until the next flush.

The removal of interceptors has developed over time. Originally, they were broken out of the inspection chamber and a short section of pipe would be inserted to bridge the outgoing pipe over the syphon that was part of the existing interceptor. This was then grouted in and benched back into
